Libby Asbestos Site, Operable Unit 4 Libby, Montana

Final Remedial Investigation and Removal Action Work Plan for Riverside Park

September 2003

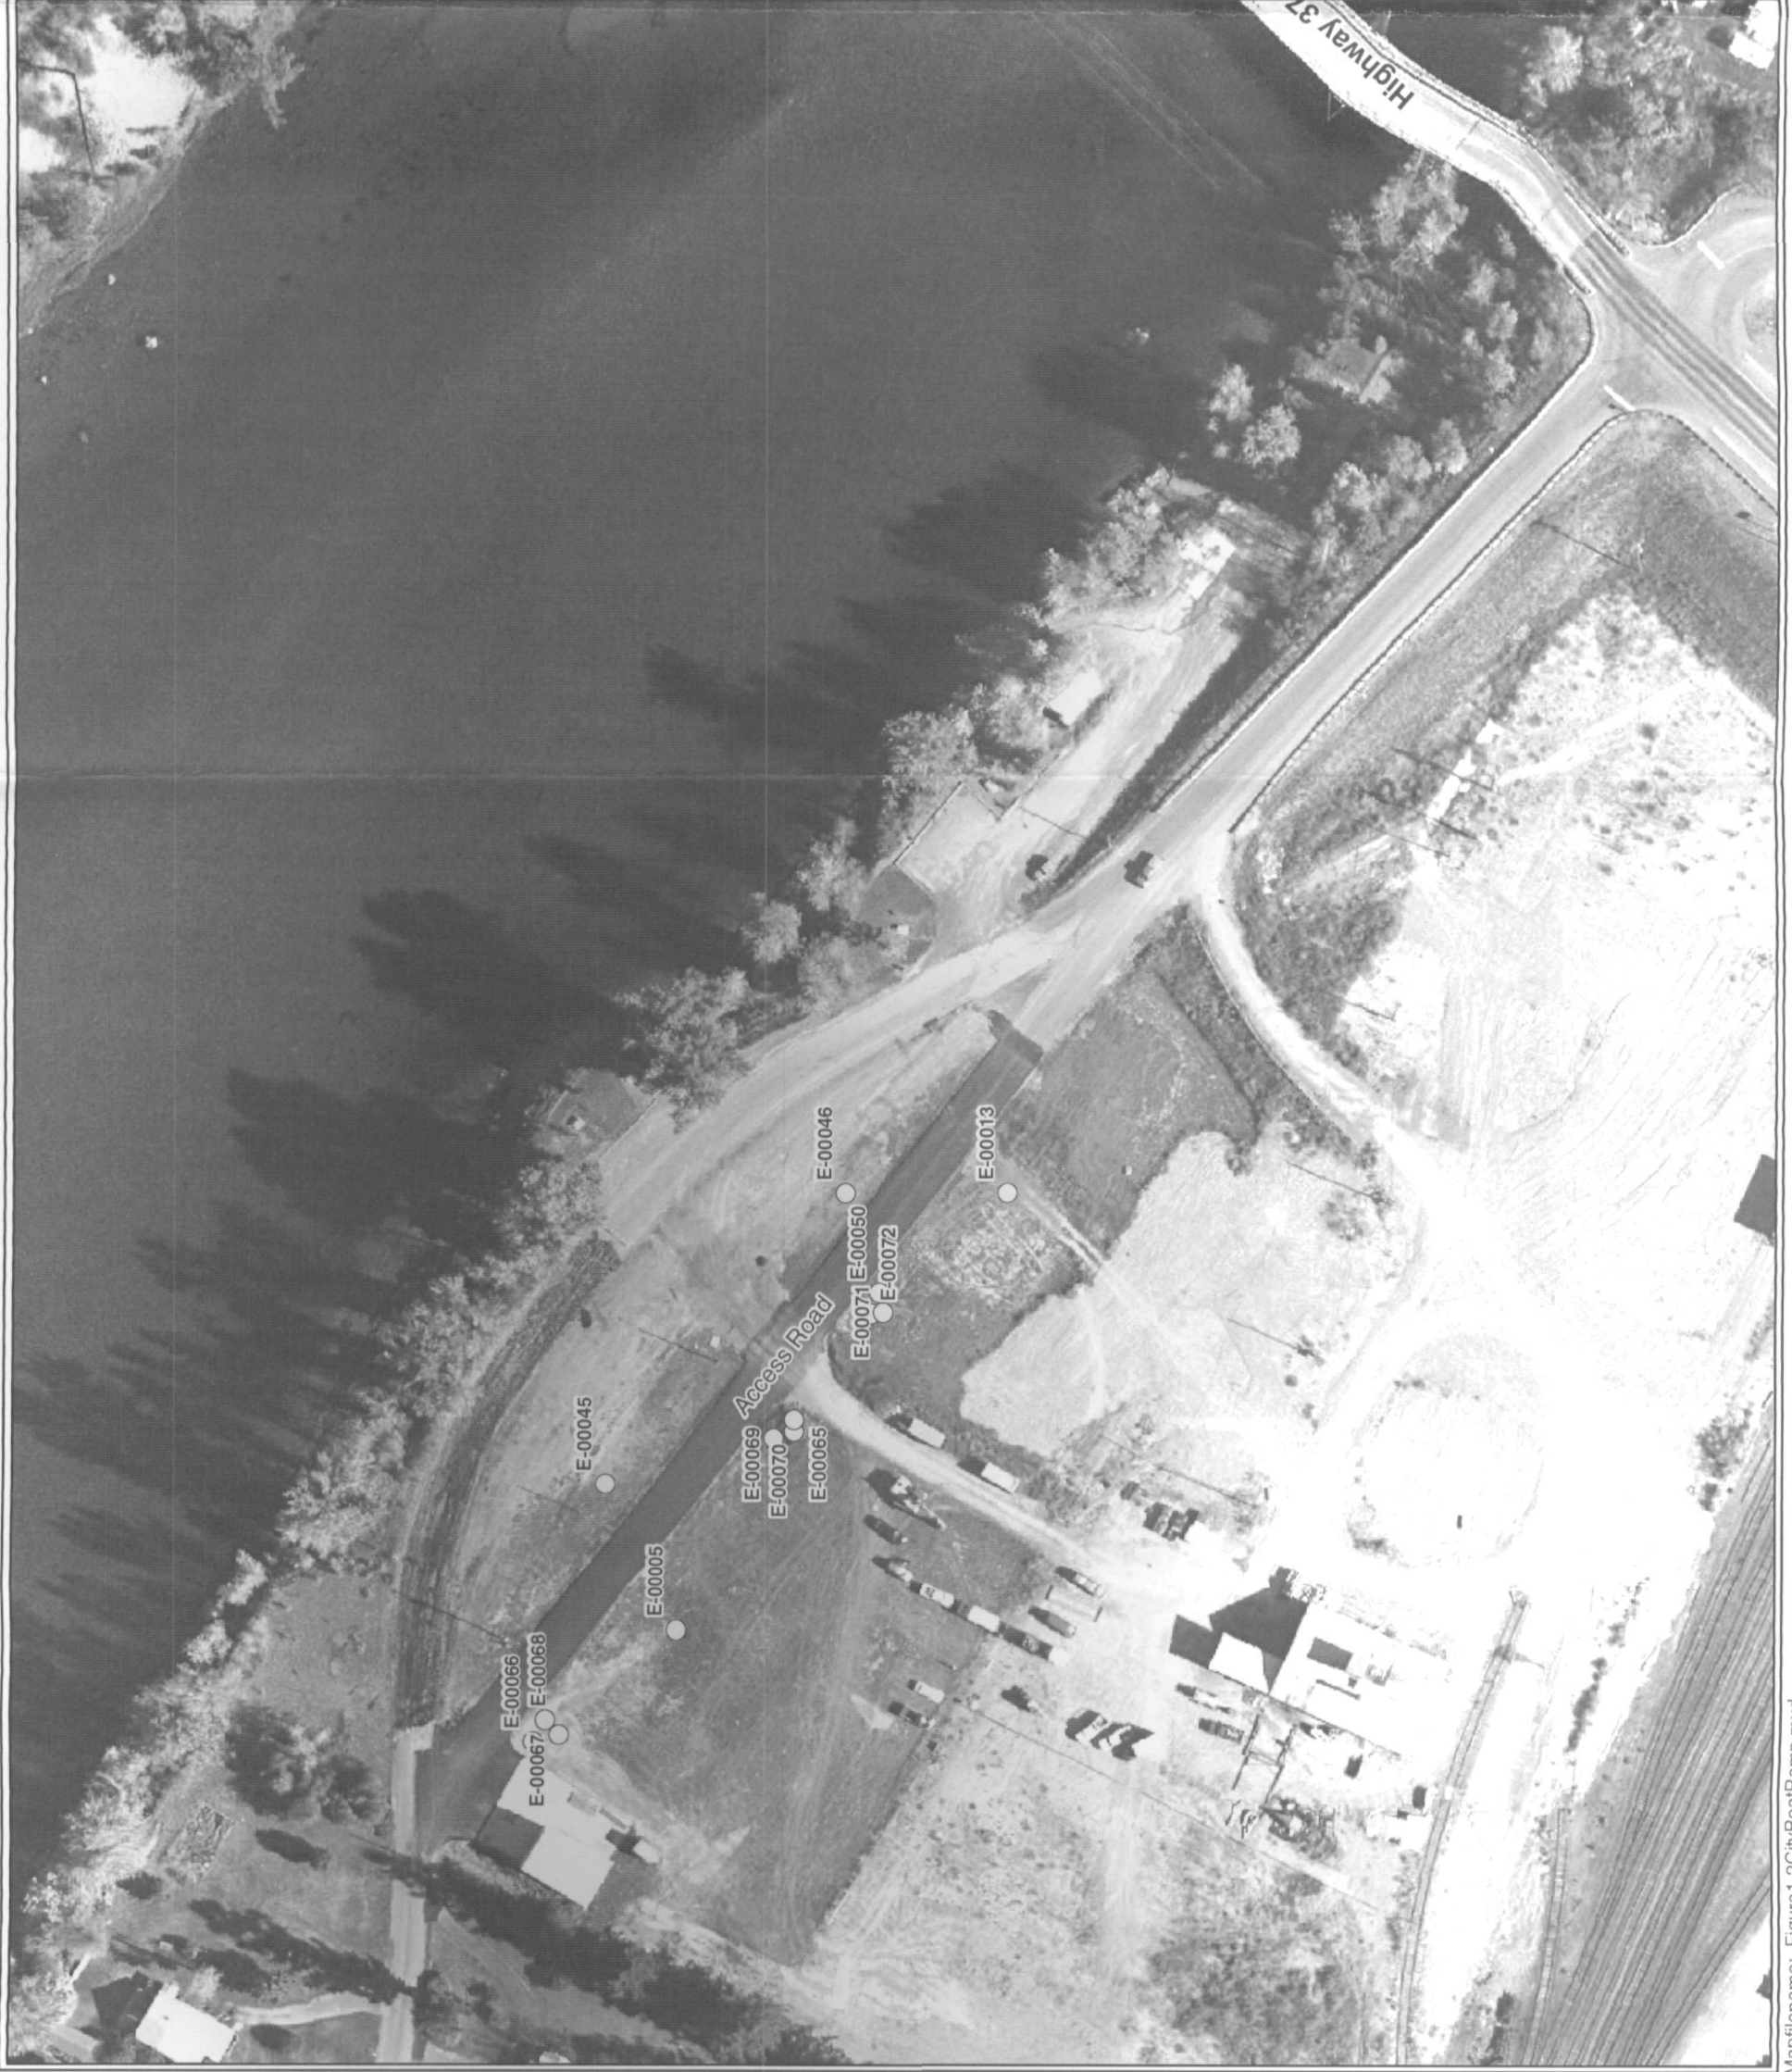
Figure 1-2
Selected Soil Samples from
the Former Export Plant
Riverside Park
Libby, Montana

W.R. Grace implemented cleanup activities at the former export plant in 1999. In December 1999, CDM collected confirmation soil samples (Figure 1-2) in order to evaluate whether or not W.R. Grace's removal objectives had been met for the former export plant. Eleven surface soil samples were collected along the south side of the access road bordering the former plant and Riverside Park. Two additional surface soil samples were collected inside the park, within 30 feet of the road. Soil samples were submitted for Libby amphibole (LA) asbestos determination by polarized light microscopy (PLM) (National Institution of Occupational Safety and Health [NIOSH] 1994). The analytical results for all samples were non-detect.

- Sample Locations (12/99)

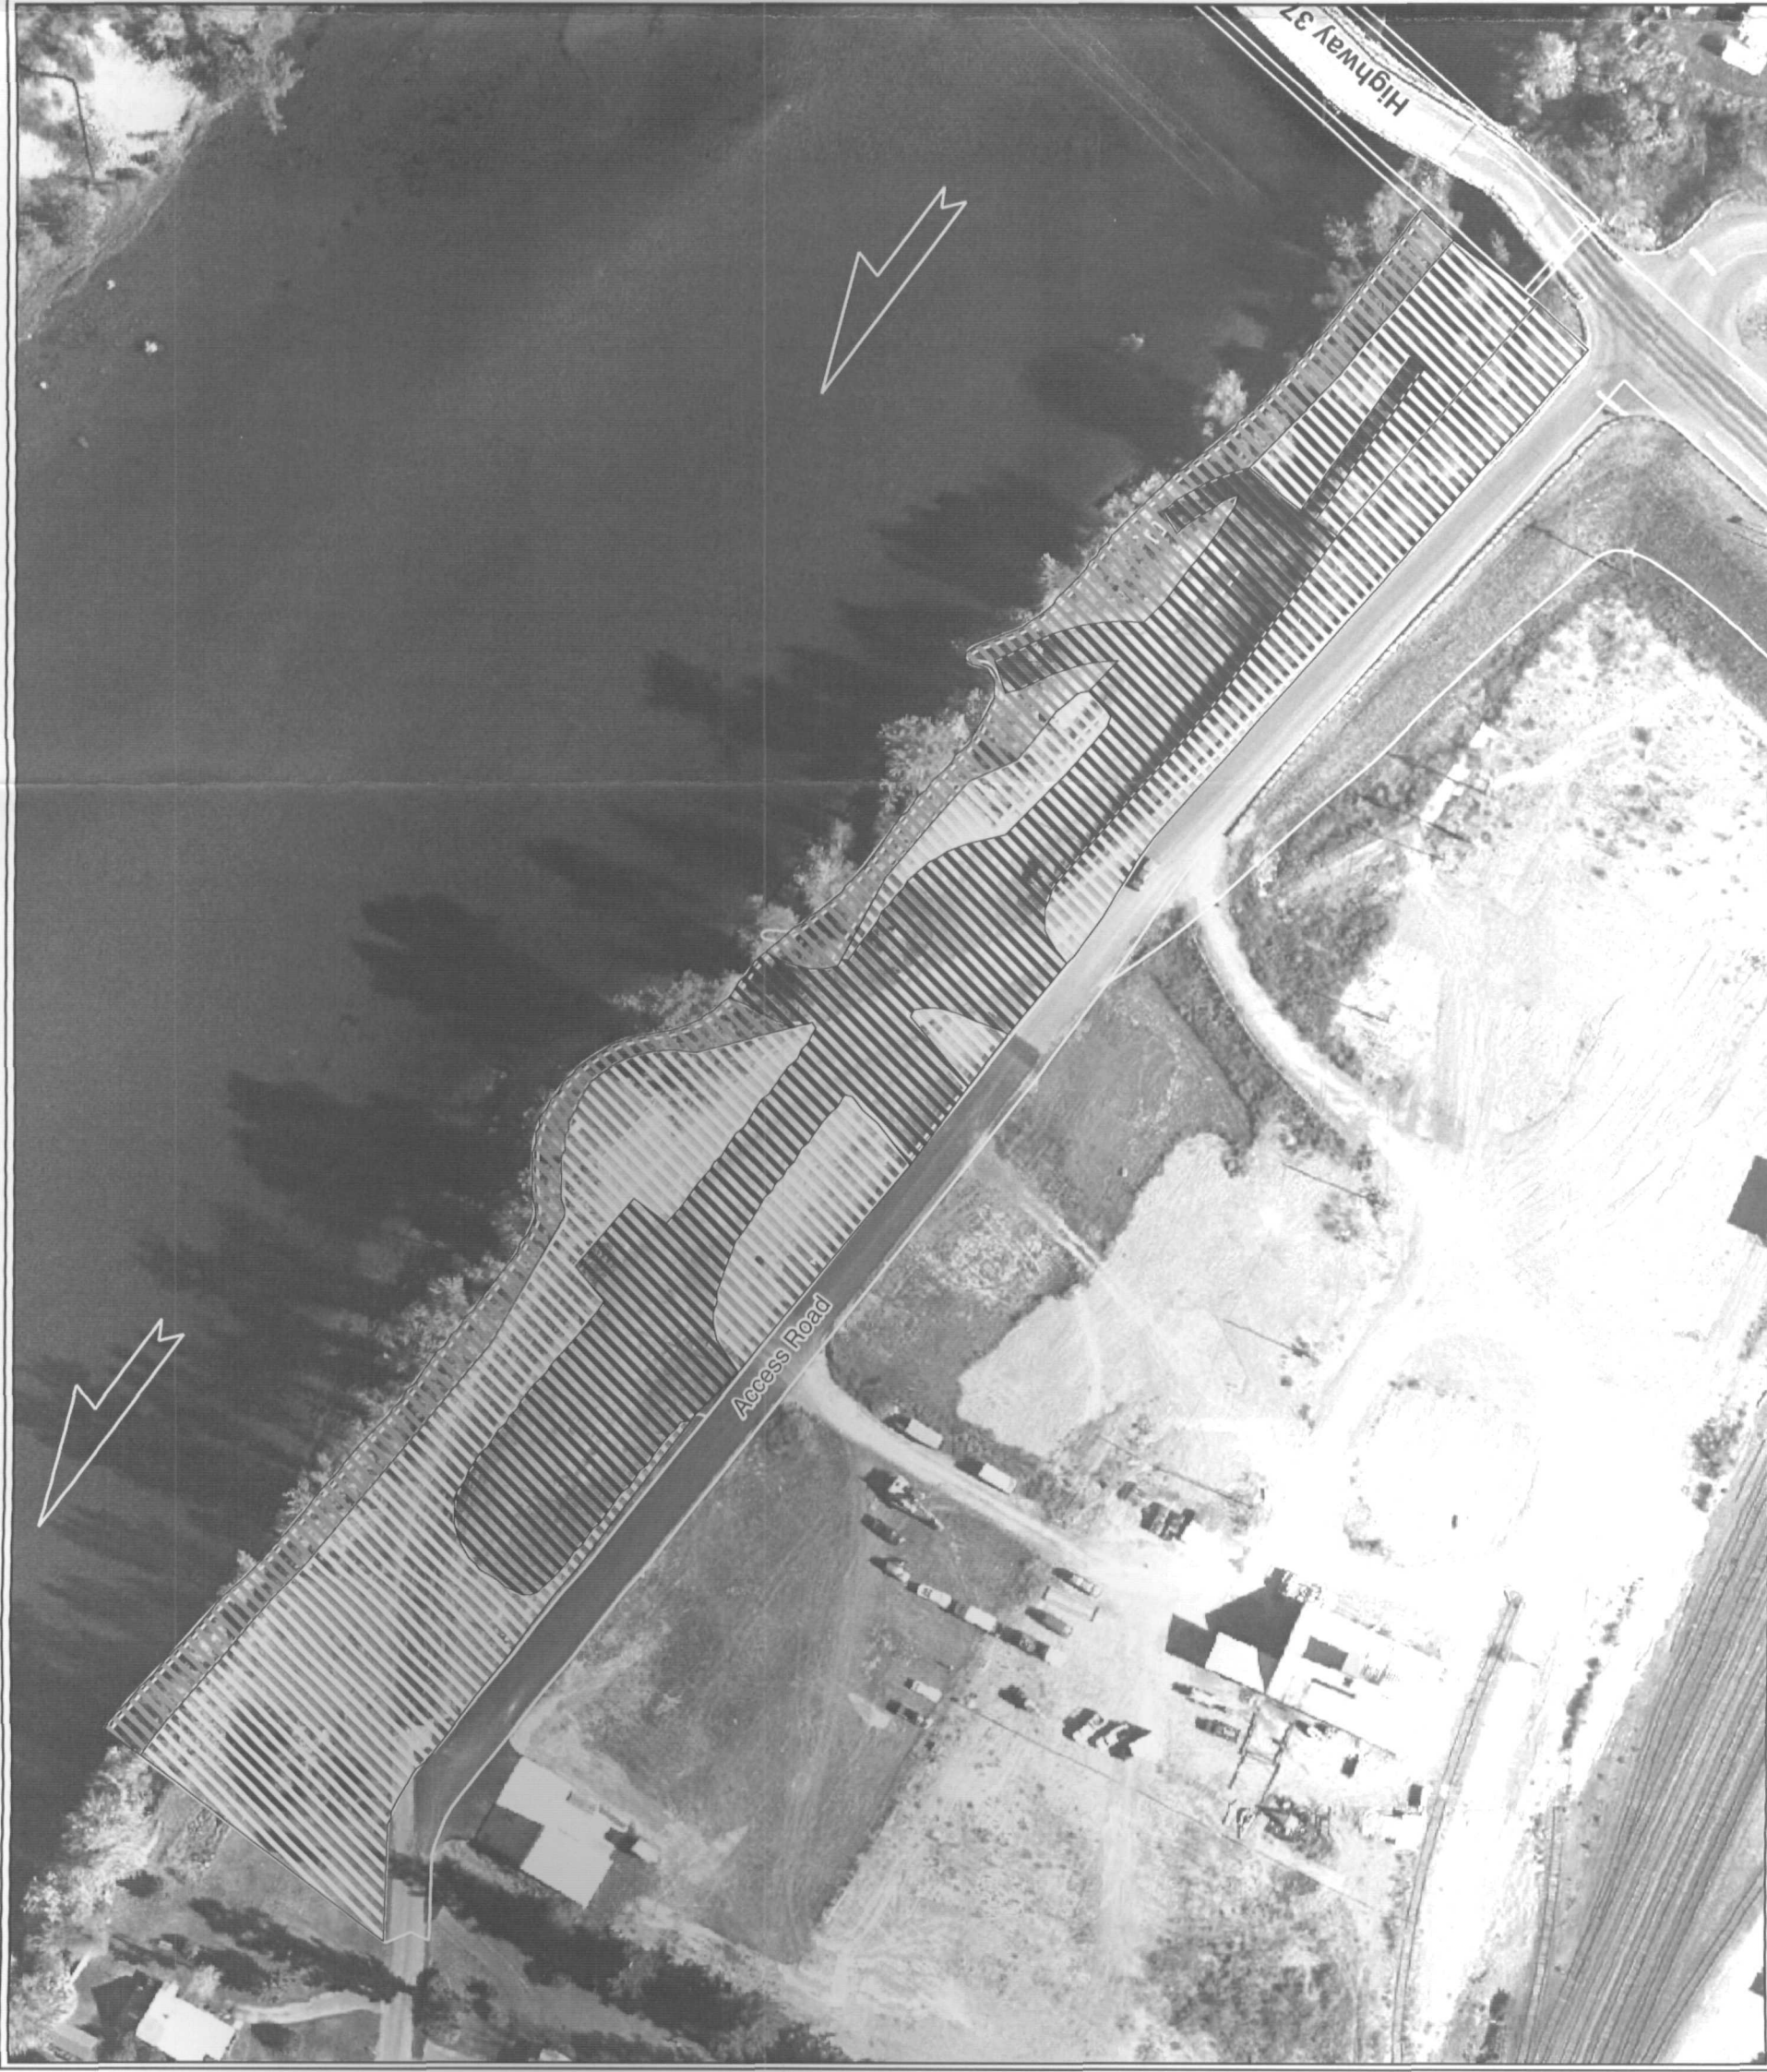
Figure 1-3
Park Renovation Plan
Riverside Park
Libby, Montana

The City of Libby initiated renovations to the park in May of 2003 (Figure 1-3). While constructing a new boat ramp a 2-inch thick layer of vermiculite, along the west side of the ramp leading down to the water, was discovered. The layer is approximately 8 to 10 inches below the grass surface and is exposed along the ramp (Figure 1-4). In addition, during site renovations for the picnic areas, overburden material was scraped off the top of the bank west of the new boat ramp and pushed over the bank. This scraping exposed additional contamination in the picnic areas above the bank.

Legend

Land Use Area

- Picnic
- Riverbank
- Road/Parking

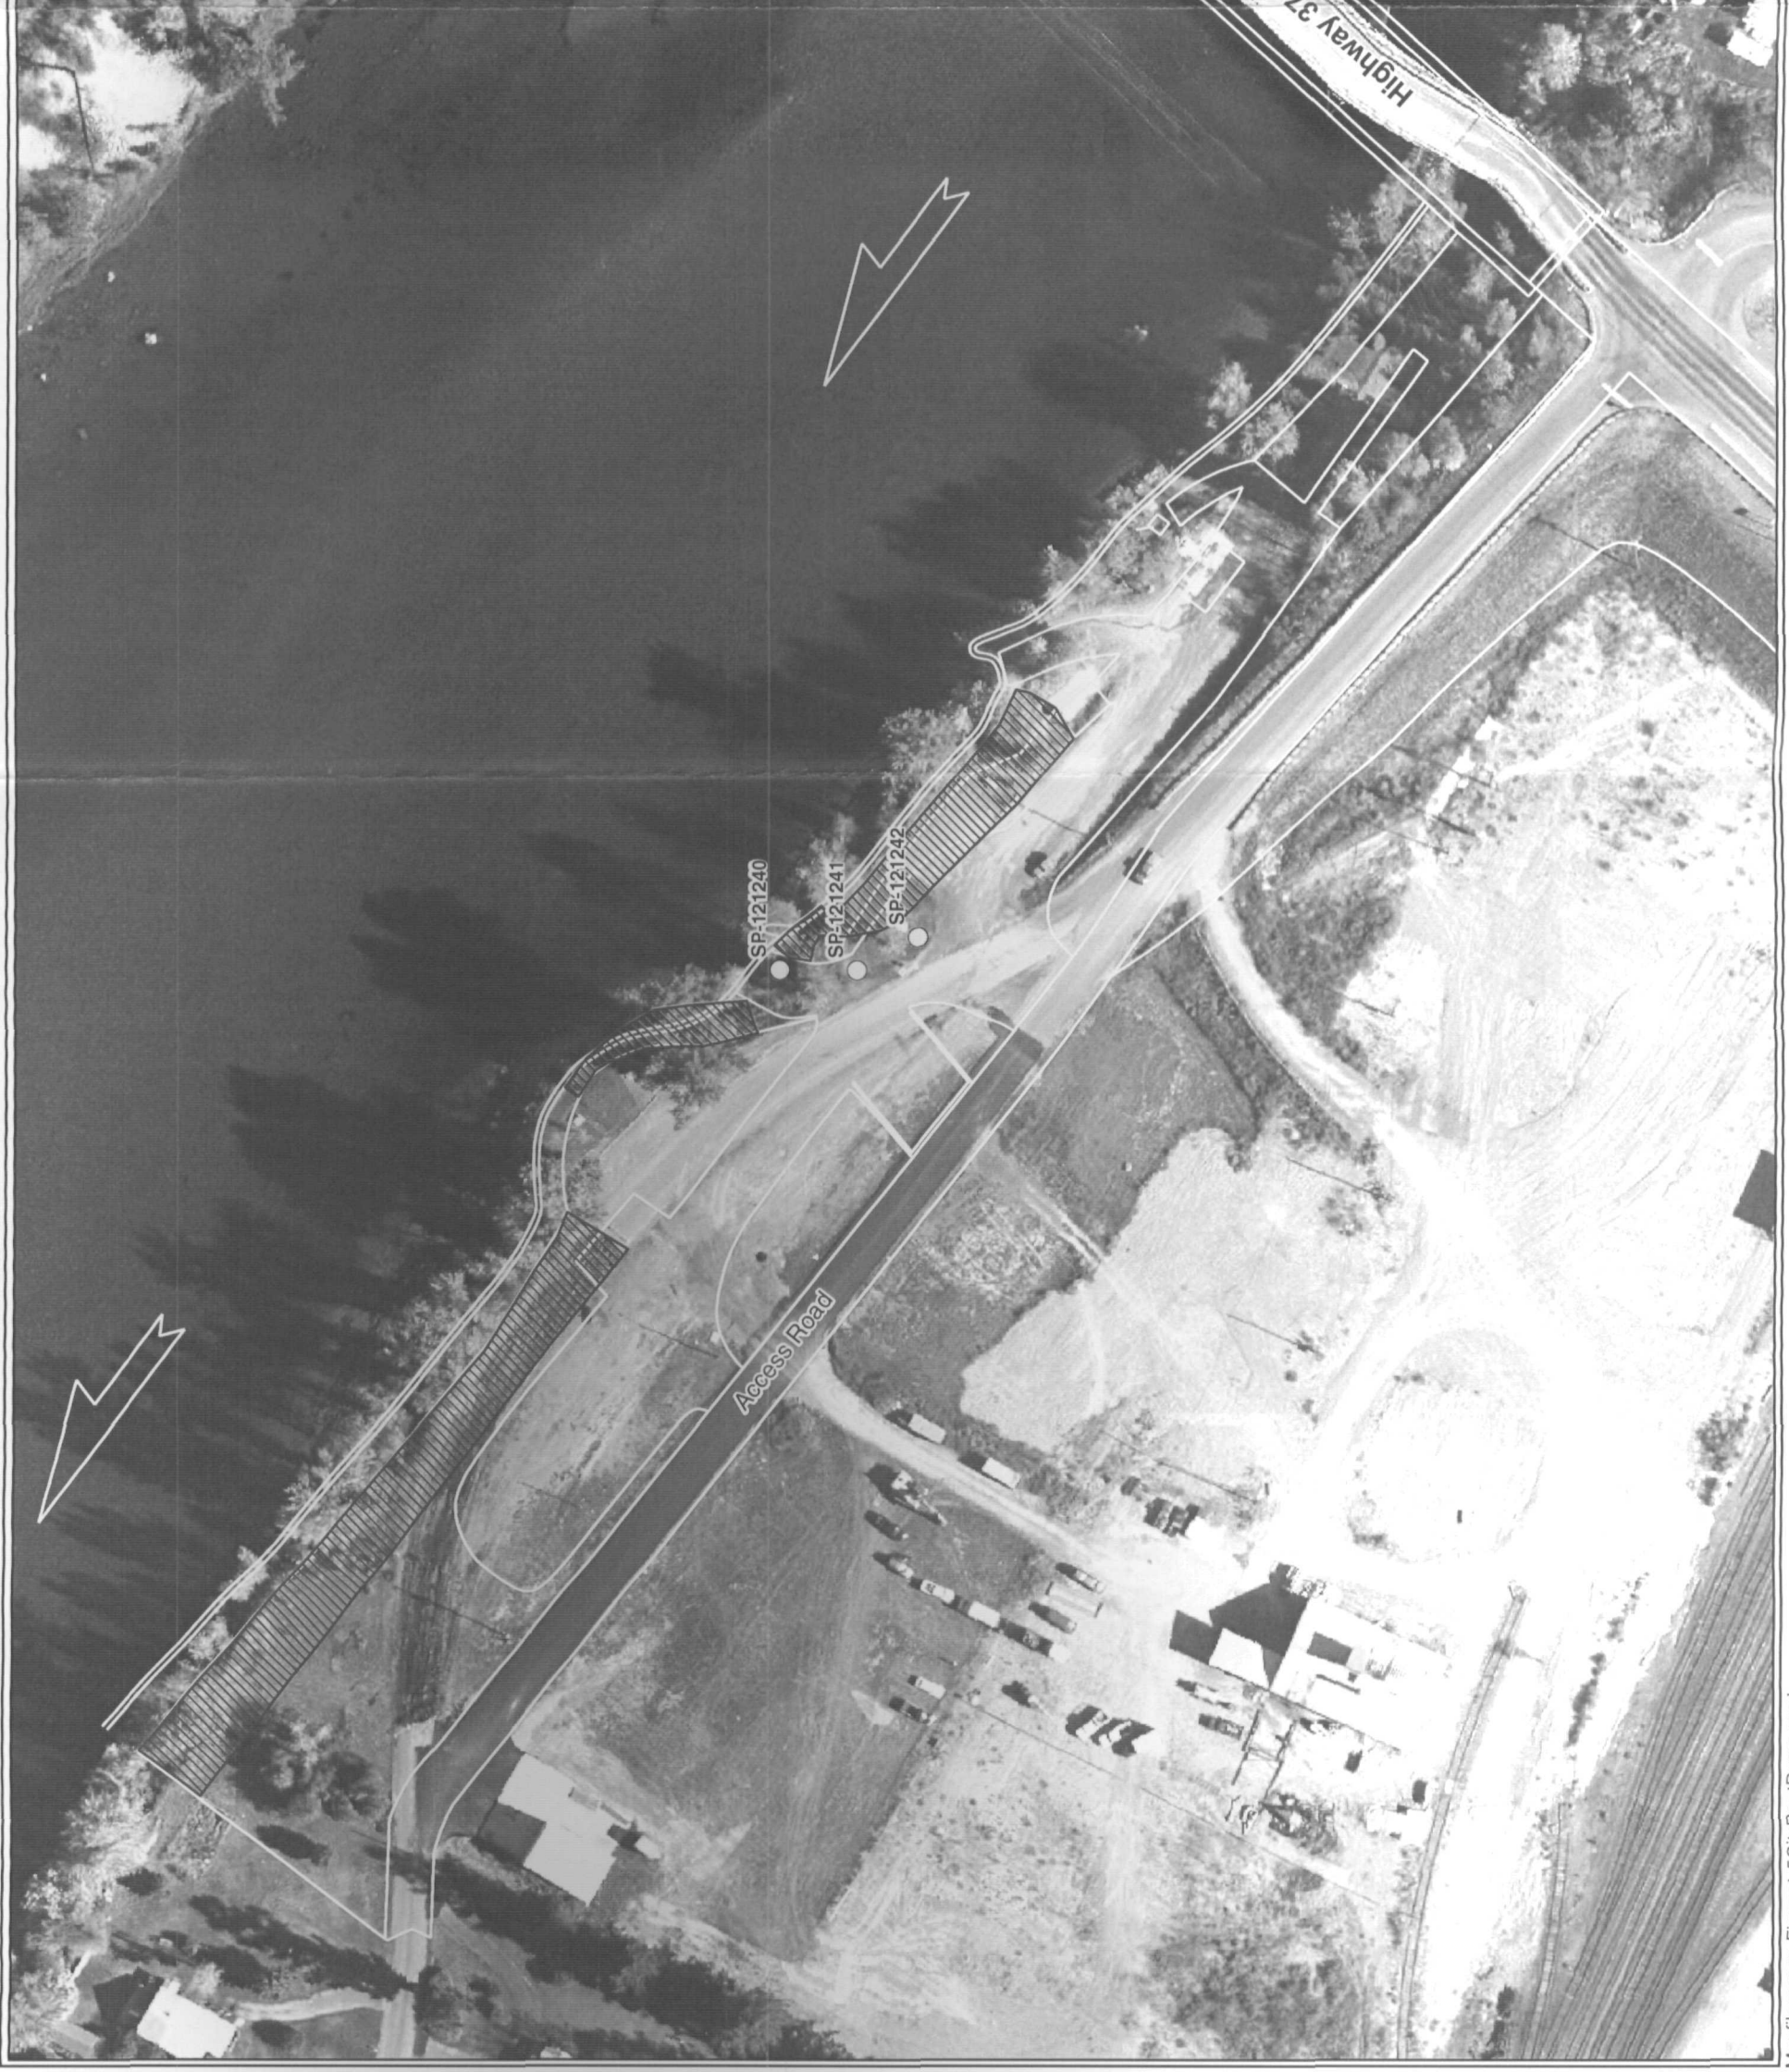
Figure 1-5
Overview of May 22, 2003 Site Visit
Riverside Park
Libby, Montana

Legend

○ Sample Locations (5/22/03 Site Visit)

▨ Tarped Areas

In conjunction with the May 22 soil sampling, the park was visually inspected for contamination. Visible vermiculite and other apparent asbestos contamination was found in the park and along the banks of the Kootenai River. After inspecting the site, CDM and Volpe covered and fenced off those areas in the park with the highest concentration of visible contamination in order to mitigate the short-term exposure hazard (Figure 1-5). Erosion control fabric and silt fences are also being installed along the riverbank as interim measures until the site is remediated.
